MAY 1979

HUMBOLDT DAM

NDI ID No. PA-00646
DER ID No. 40-61

PHASE I INSPECTION REPORT
NATIONAL DAM INSPECTION PROGRAM

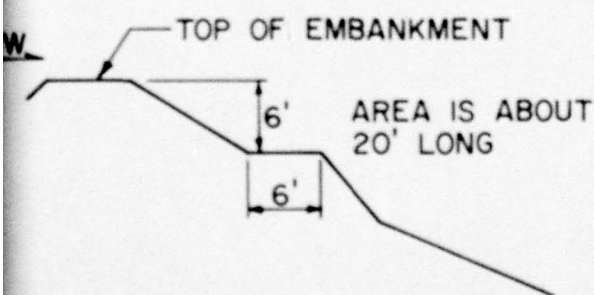
DETAIL A
NOT TO SCALE

The downstream slope is thickly covered with mature trees. Near the right abutment, there is a discontinuity in the slope. The area is sketched on Detail A of Plate B-1. There are numerous wet areas along the toe of the dam. Clear seepage was observed at some of the wet areas. The approximate location of the conditions is shown on Plate B-1. The growth along the toe hindered the inspection of these areas. It should be noted that heavy rains occurred three days previously. There are mounds along some of the toe. A typical area is sketched on Detail B on Plate B-1.

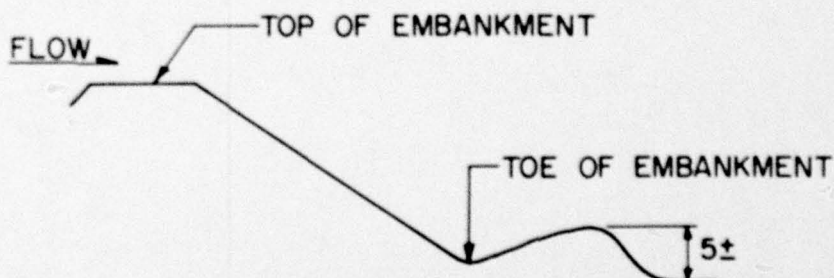
DETAIL B
NOT TO SCALE

NOTE: THIS IS
TYPICAL FOR
AREAS ALONG TOE

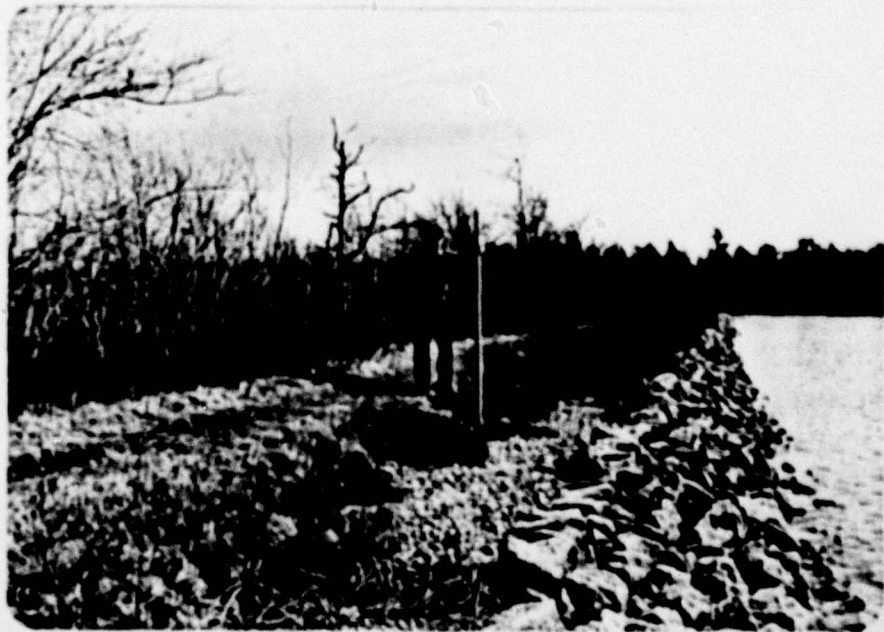
B. Upstream Slope

b. Embankment. The embankment is in poor condition. Brush extends along the upstream slope. The riprap along the upstream slope is either washed out, leaving the bedding material exposed, or weathering has deteriorated the riprap to the extent that it is no larger than gravel. The upstream edge of the top of the dam is eroded. The erosion has resulted in the top of the slope being vertical in many places. A maximum height of 1.5 feet was measured at one of these areas.

- (5) Replace the riprap on the upstream slope.
- (6) Remove the debris from the spillway outlet channel and the outlet works channel.

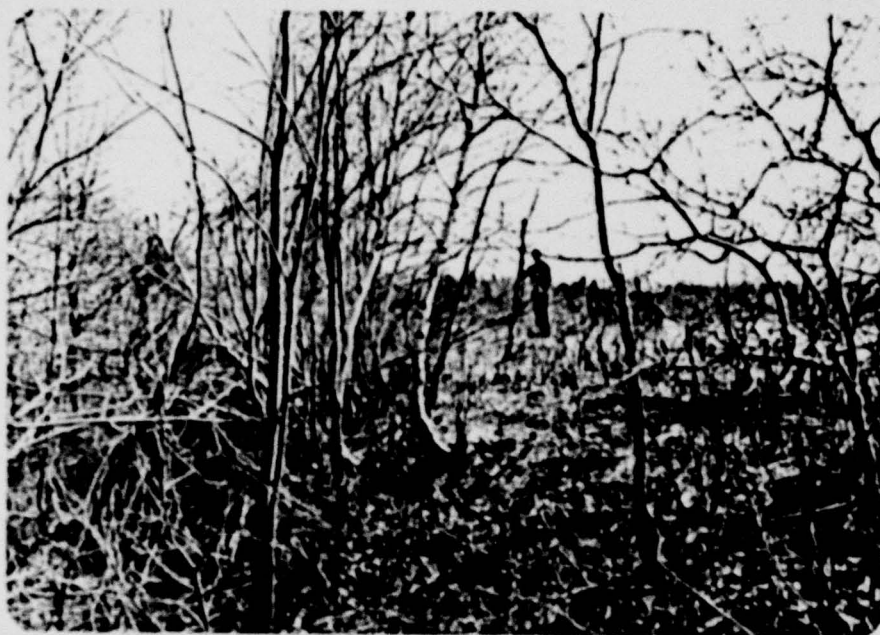
C. Downstream Slope

(2) Embankment. The brush on the upstream slope is undesirable. The deteriorated or washed out riprap is an erosion hazard. The trees on the downstream slope are of serious concern. Their large size indicates that brush cutting has not been accomplished on the downstream slope for many years.

- (3) Engage the services of a professional engineer experienced in the design and construction of dams to determine the best method of removing the trees on the downstream slope and near the toe and to determine measures necessary to ensure that the integrity of the dam is preserved. Implement his recommendations.

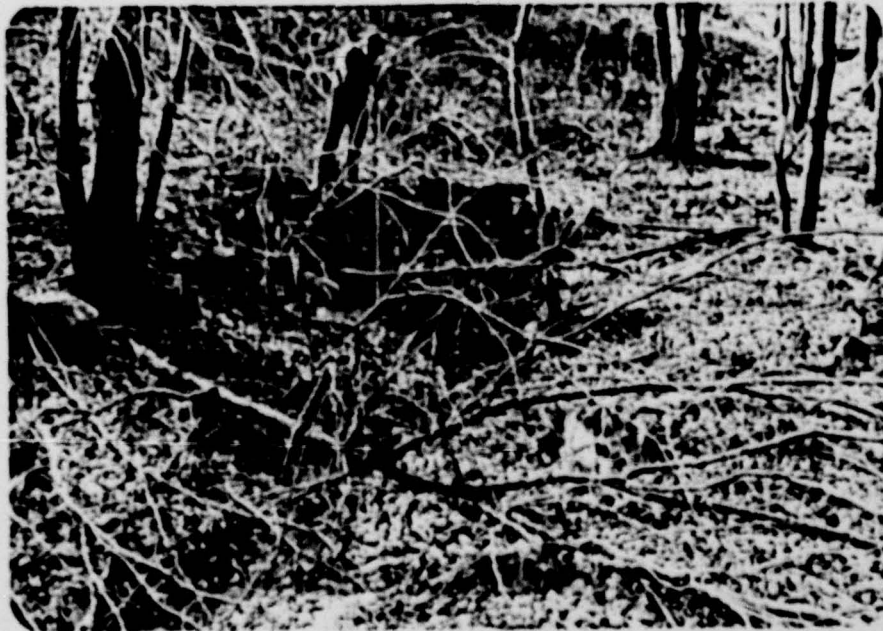
F. Downstream Outlet Works Valve House

The outlet works is in poor condition. The intake structure is in good condition, as is the access bridge. The valve house at the downstream toe of the embankment is in poor condition. The roof is collapsed; it fills the interior of the valve house. There appears to be no ready access to the valves therein. The downstream channel is filled to the axis of the outlet pipe with muck and small debris. The Owner declined to operate the valve. He was concerned that the valve would remain in the open position, thus draining the reservoir.
